**2 KEHR'S MILL TRAIL UPPER DAM**

**5 ST. LOUIS COUNTY, MISSOURI**

**6 PHASE 1 INSPECTION REPORT  
NATIONAL DAM SAFETY PROGRAM**

**NOVEMBER 1980**

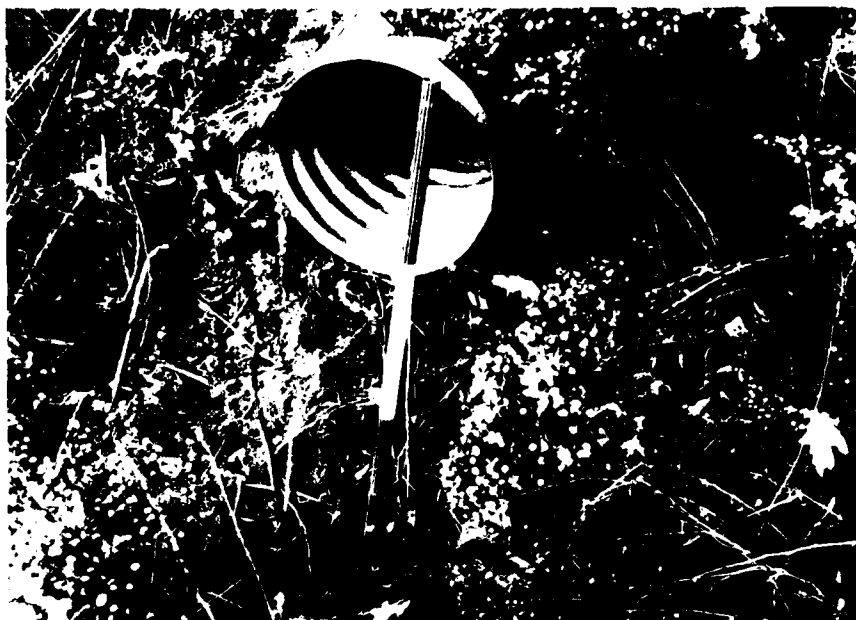
According to Dick Manlin leakage from the lake was occurring through a bad valve in a 12-inch PVC drain line. The valve has been repaired.

PHOTO 17: OUTLET OF DRAIN PIPE AT DOWNSTREAM TOE OF DAM

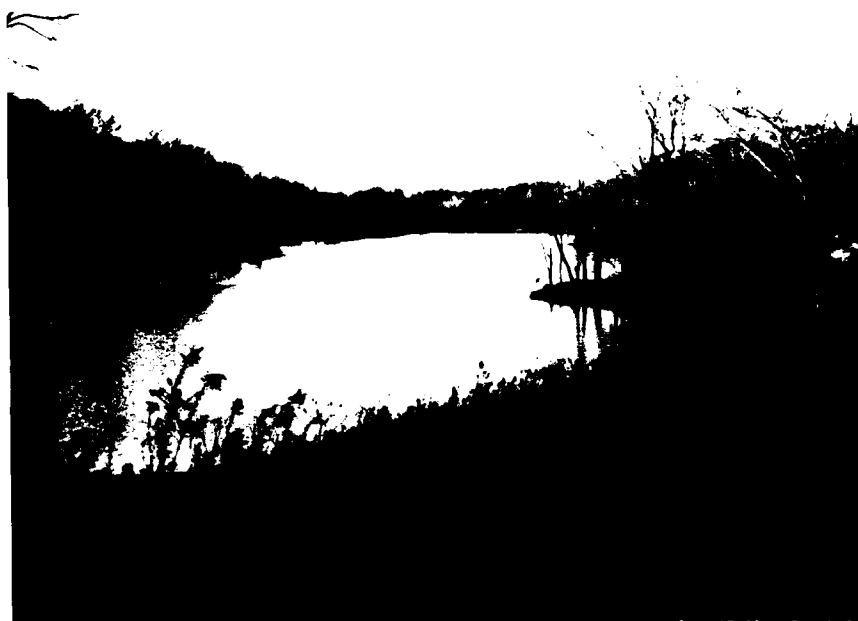
PHOTO 18: LOWER LAKE AND DAM VIEWED FROM UPPER DAM
